VISUAL SITE INSPECTION SUMMARY AND PHOTOGRAPHS

Clark Oil & Refining Corporation (Clark)
131st & Kedzie Avenue
Blue Island, IL

Date: August 21, 1991

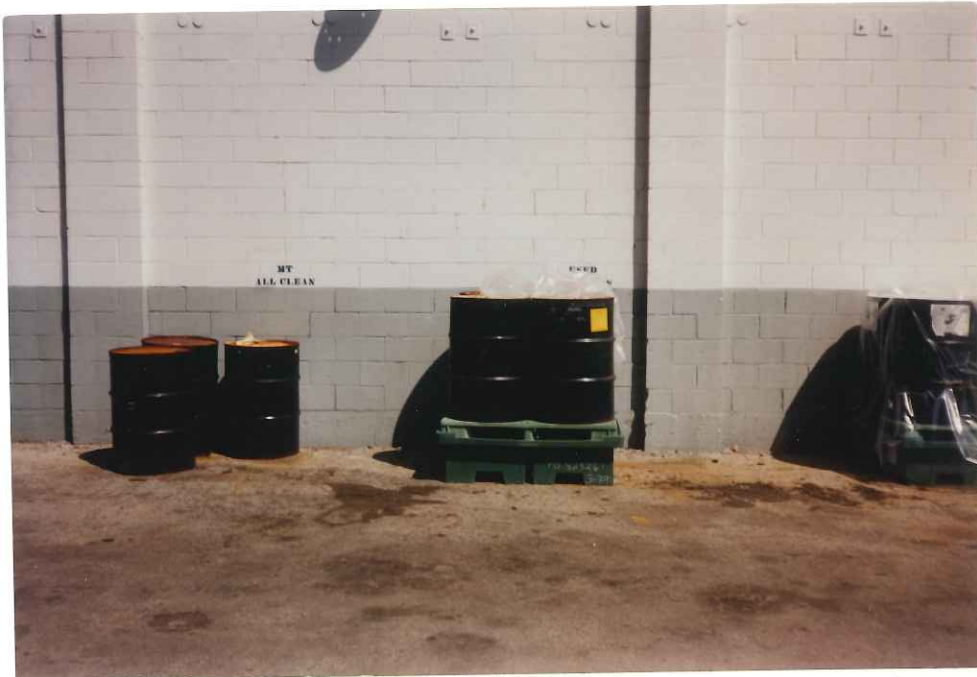
Photograph No. 1

Description: Outdoor Drum Storage Area. The pallet in middle contains spent TCA and PCB-contaminated oil waste. The barrels to the left and right contain asphalt product.

Location: SWMU 1

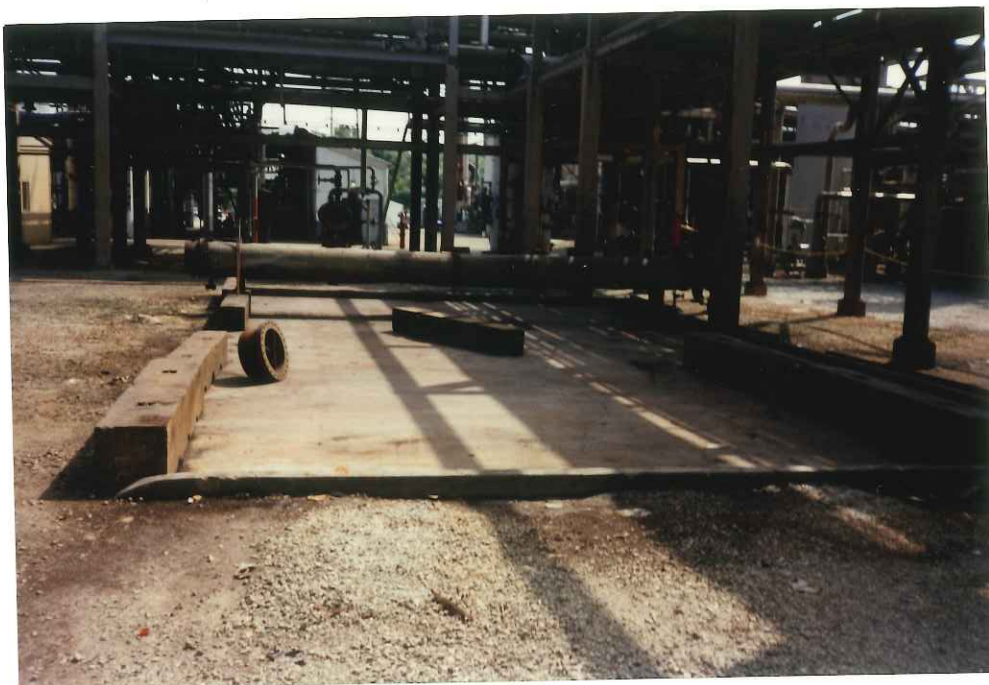
Photograph No. 3
 Orientation: South
 Description: Bundle Cleaning Pad located in Refinery Process Area.

Location: SWMU 4
 Date: 08/21/91

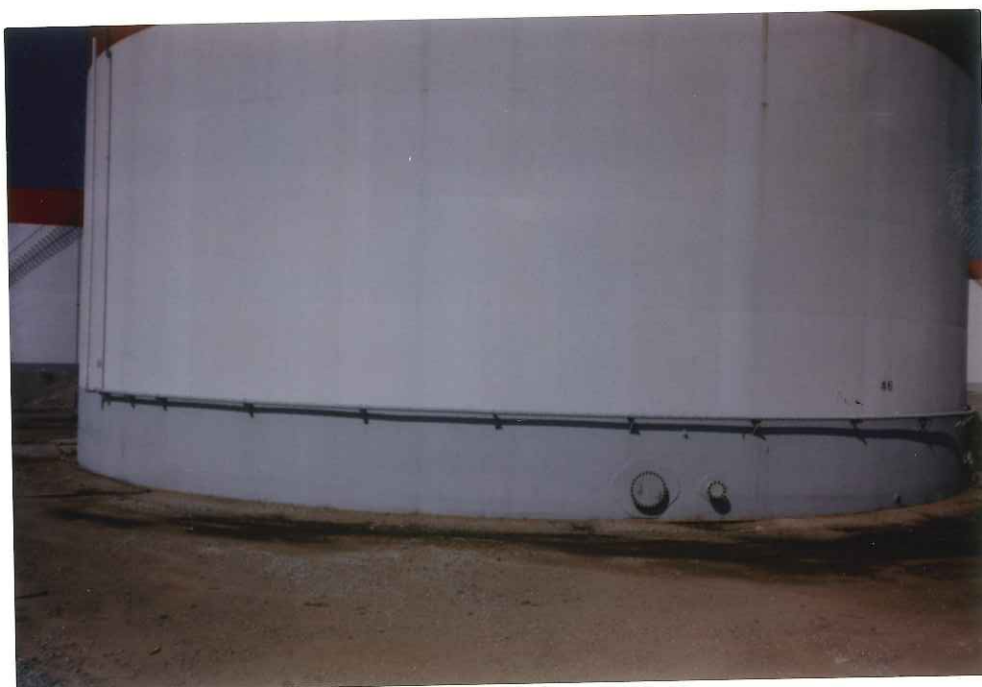
Photograph No. 4
 Orientation: Northeast
 Description: Former Satellite Accumulation Area.

Location: SWMU 5
 Date: 08/21/91

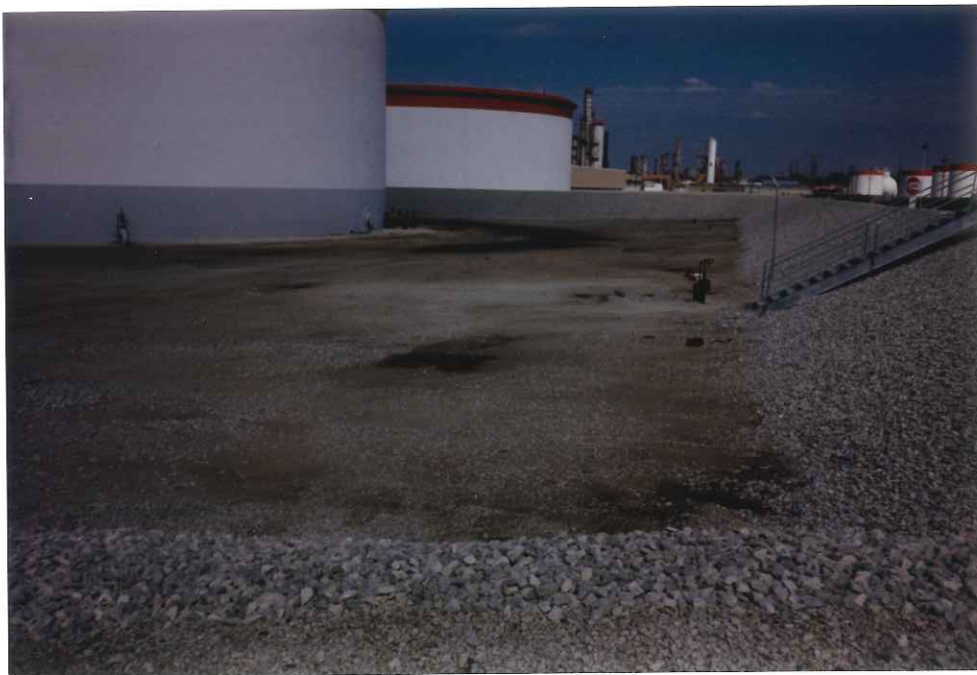
Photograph No. 5

Description: Former Storage Area. Tank #801 is in background. The empty area in right hand bottom corner is where unit was located.

Location: SWMU 6

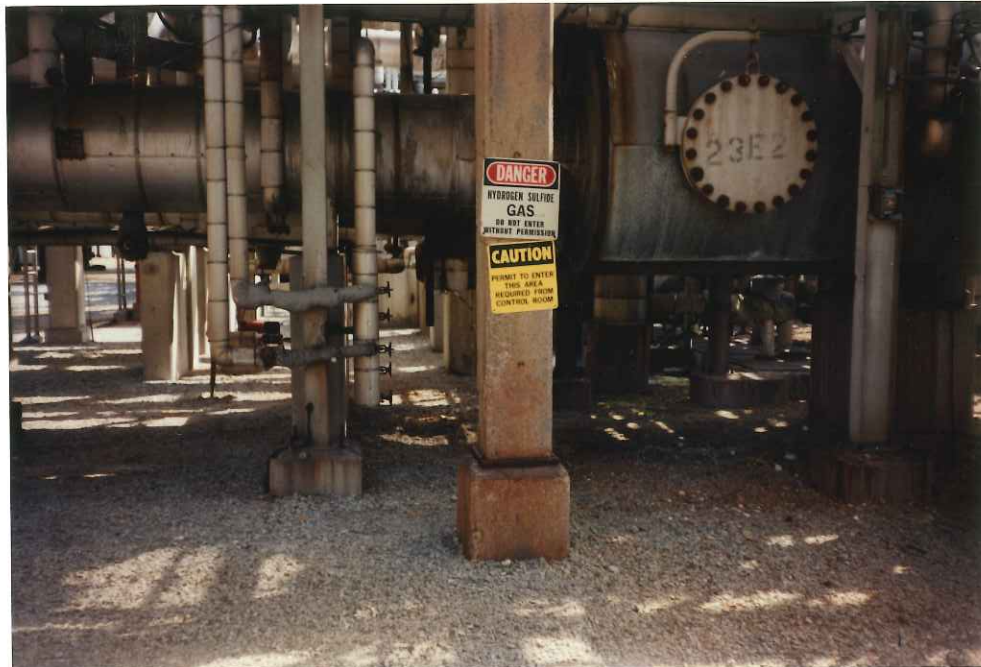
Photograph No. 6

Description: Satellite Accumulation Area for Scrap Sulfur.

Location: SWMU 7

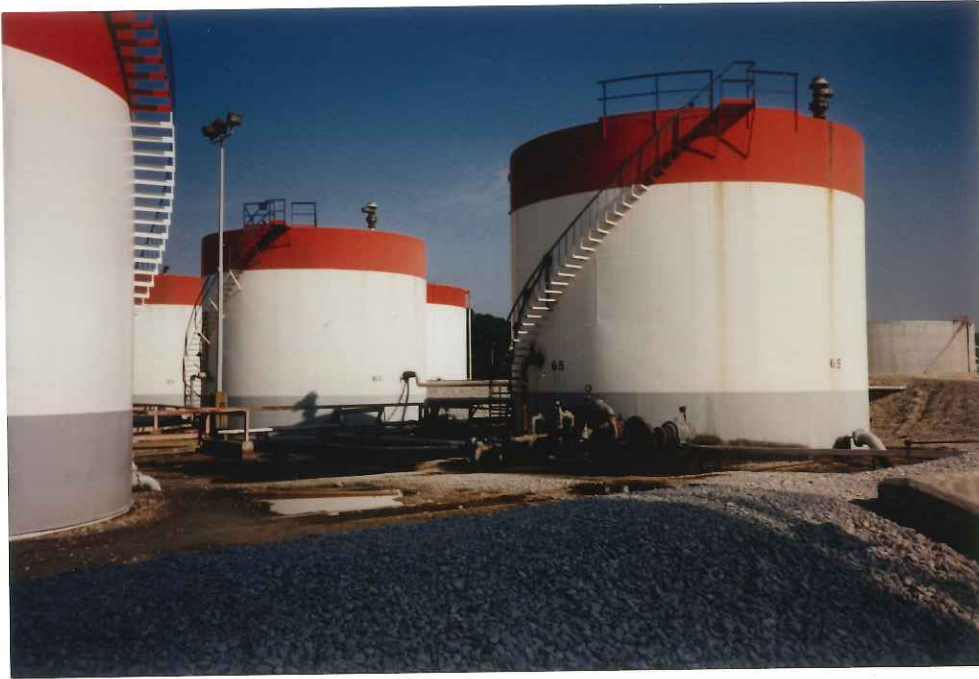
Photograph No. 7

Description: Storage Treatment Tanks. Tanks #63 and #65 (center and right) are oil-water separator units. Tank #66 (left) is a storage tank.

Location: SWMU 8

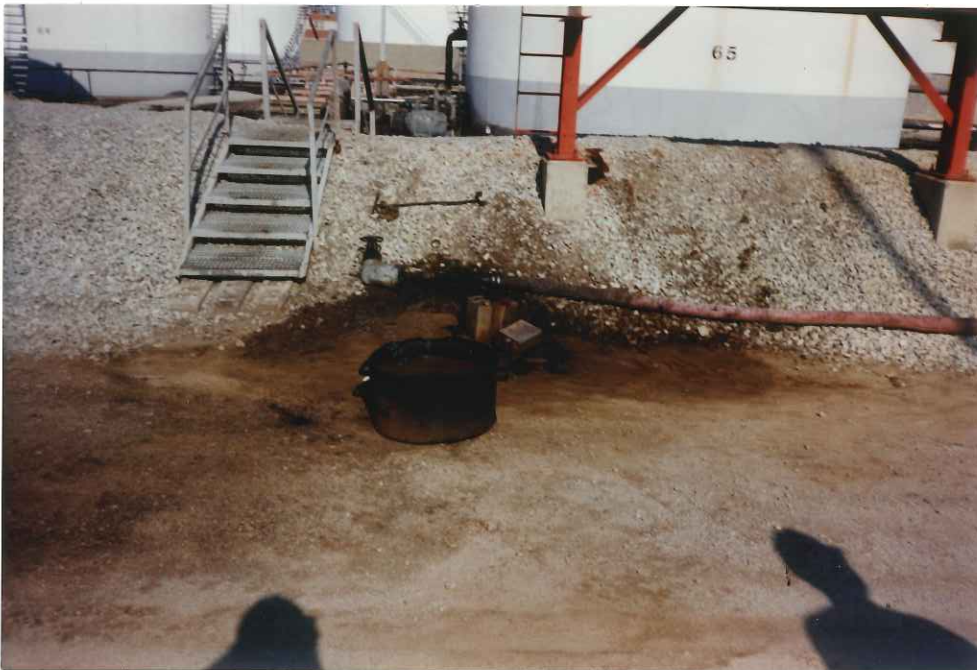
Photograph No. 8

Description: Storage Treatment Tanks and pipeline connection to tanker truck waste disposal pumping station. A full dip pan is in foreground. Note heavy soil staining in center.

Location: SWMU 8

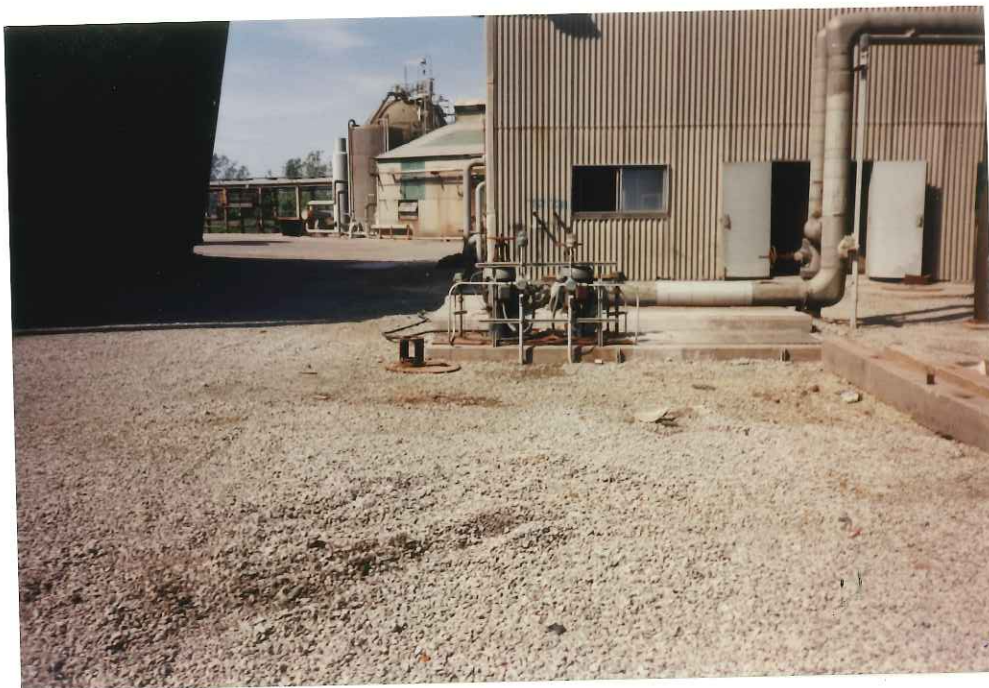
Photograph No. 9

Description: Approximate location of Former Container Storage Treatment Area in foreground.

Location: SWMU 9

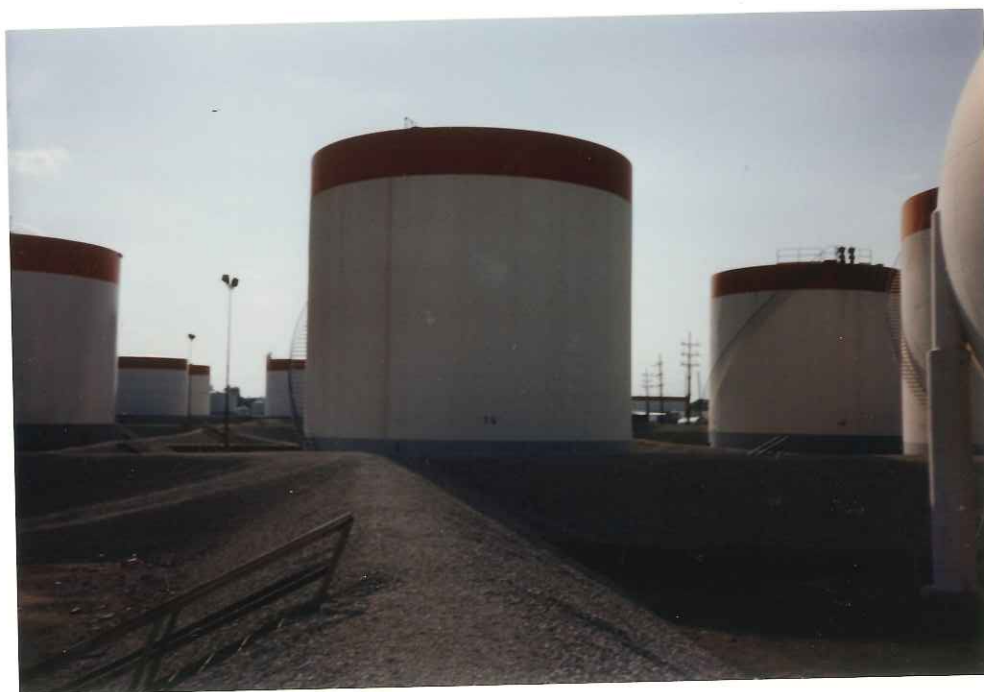
Photograph No. 10

Description: Approximate location of Former Storage Treatment Tank. According to the RCRA Part A Permit application map, this former unit was located where the dike is currently.

Location: SWMU 12

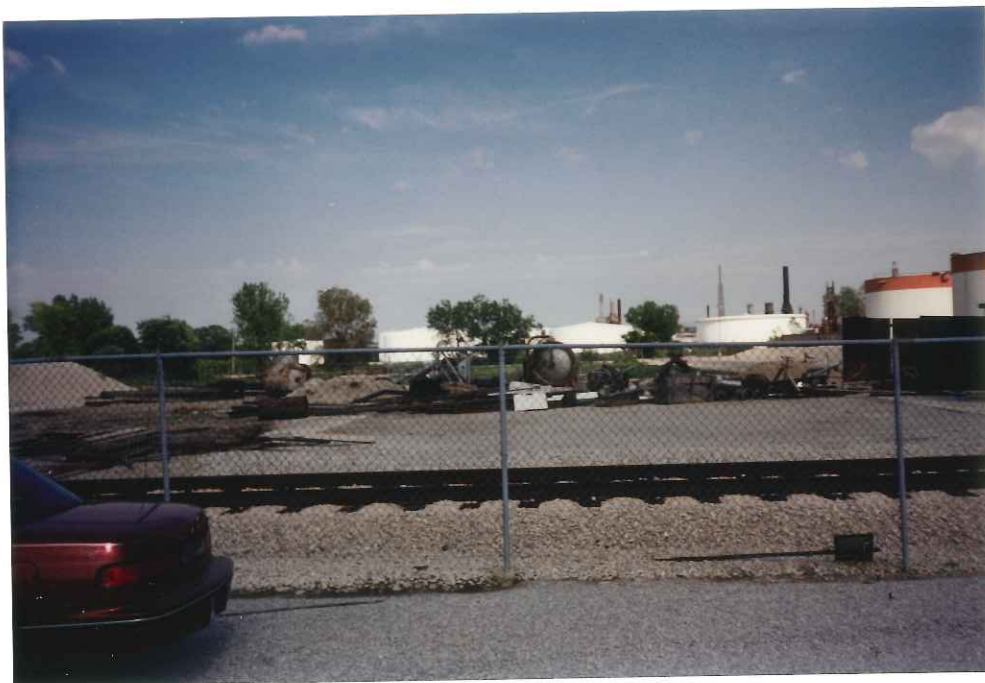
Photograph No. 11

Description: Approximate location of the Former Drum and Waste Storage Area, currently owned by BTL Industries. The unit location lies on east side of fence.

Location: SWMU 13

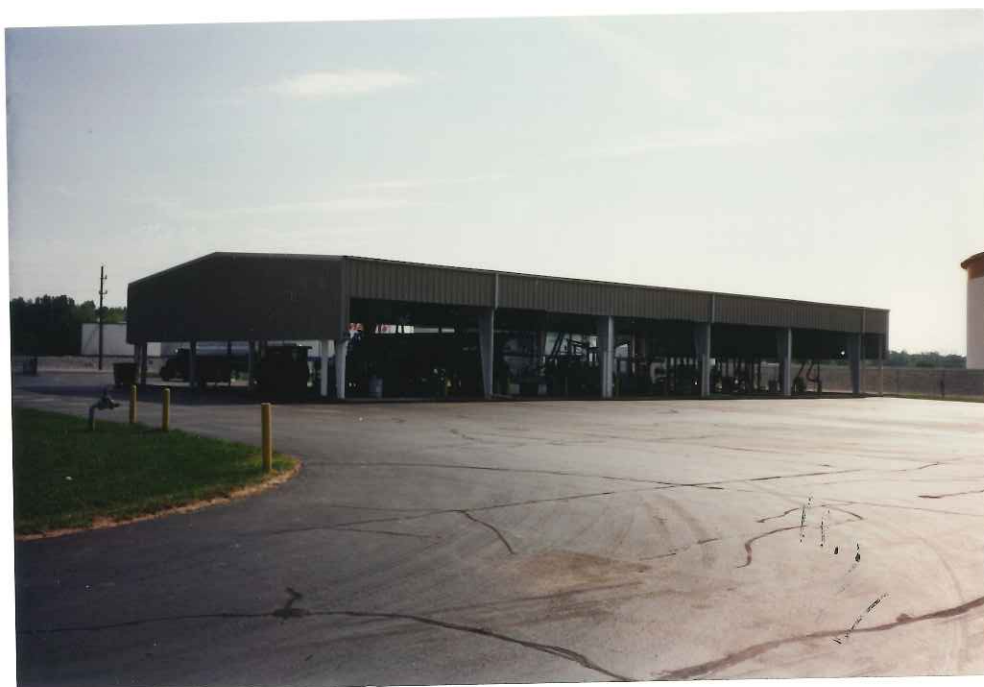
Photograph No. 12

Description: Approximate location of a Former Container Storage Area. Currently, Clark Corporation's Blue Island Terminal is situated on this former waste area.

Location: SWMU 14

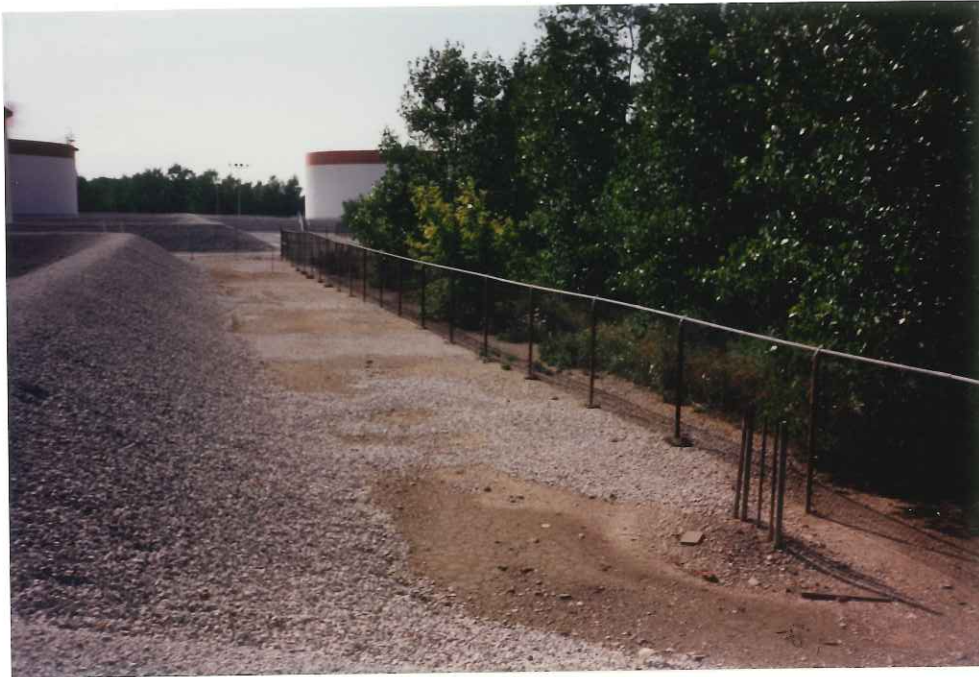
Photograph No. 13

Description: Approximate locations of a Former Container Storage Area (SWMU 15) and the Former Waste Pile Area (SWMU 16). Note electrical connection for a former flare unit in bottom right-hand corner.

Location: SWMU 15 & 16

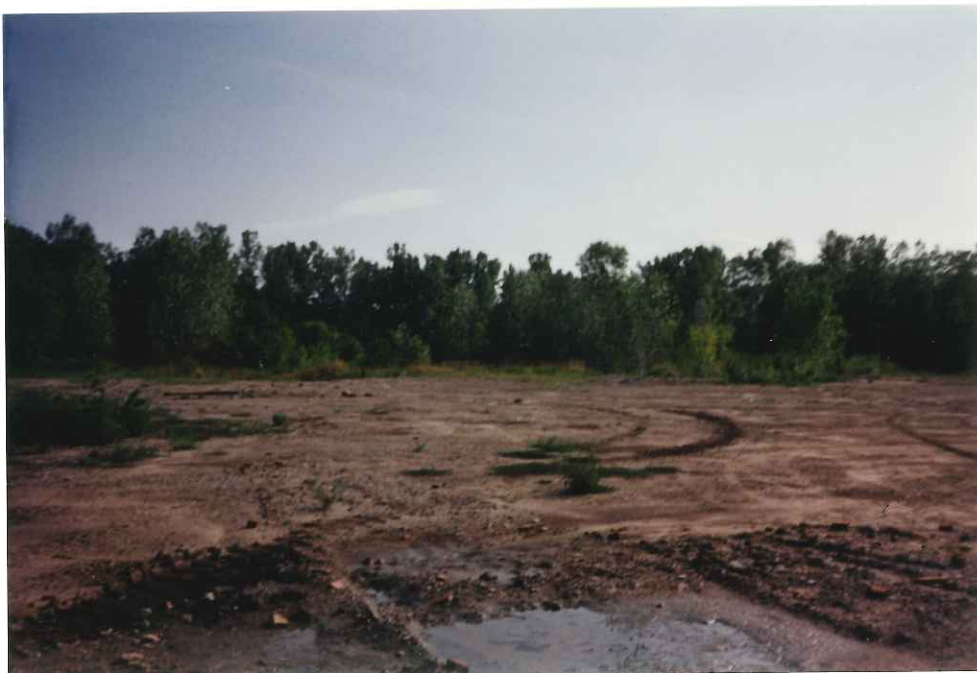
Photograph No. 14

Description: Location of the Former Waste Piles and Impoundment Area. Note lack of vegetation in center.

Location: SWMU 17

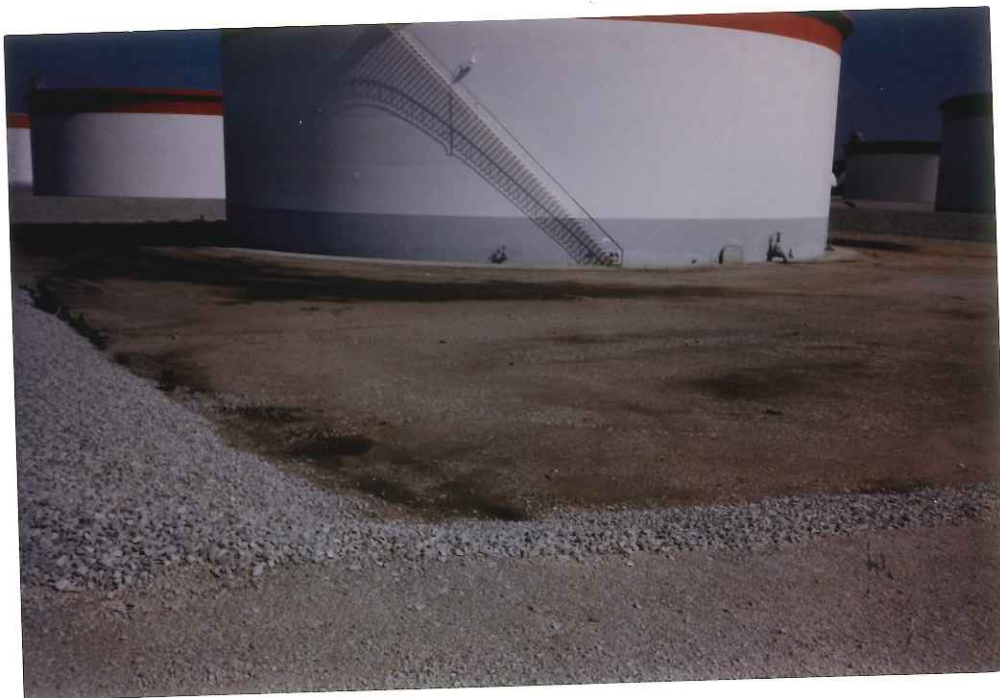
Photograph No. 15
 Orientation: Southwest
 Description: Former Impoundment Area.

Location: SWMU 18
 Date: 08/21/91

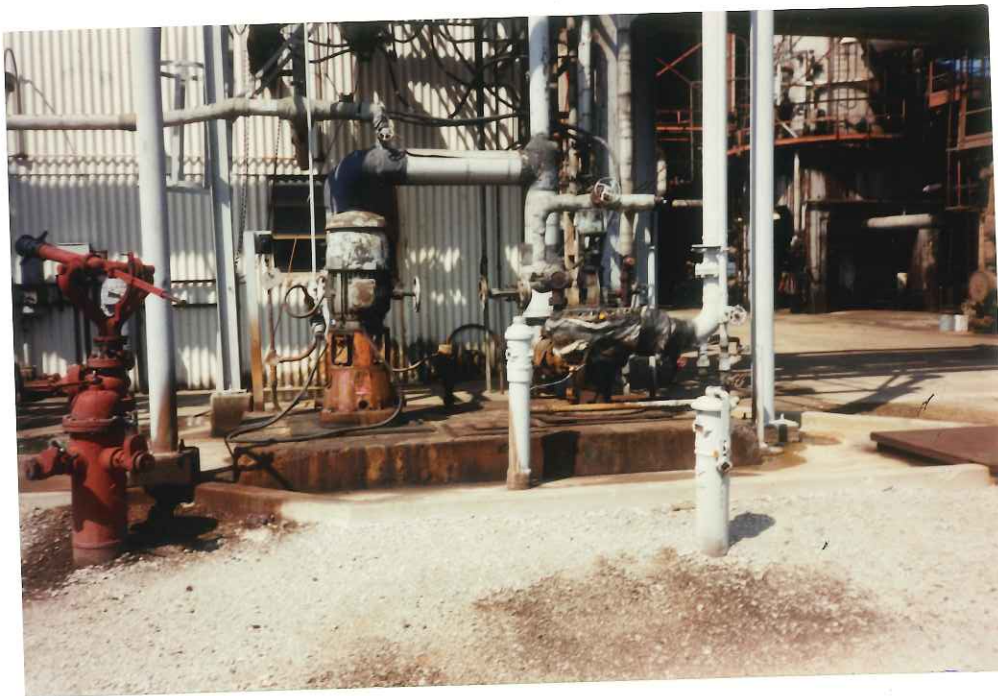
Photograph No. 17

Description: An example of an oily waste pump for the Wastewater Treatment System.

Location: SWMU 19

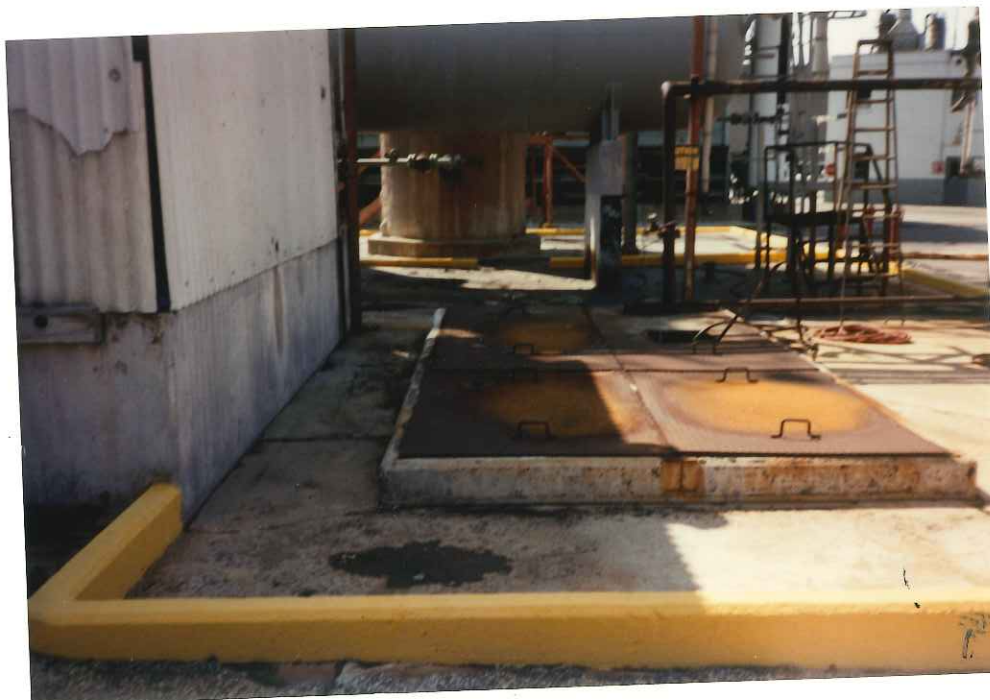
Photograph No. 18

Description: Some of the wastewater is neutralized in this alkylation neutralization permit. The neutralized wastewater is pumped to the Wastewater Treatment System.

Location: SWMU 19

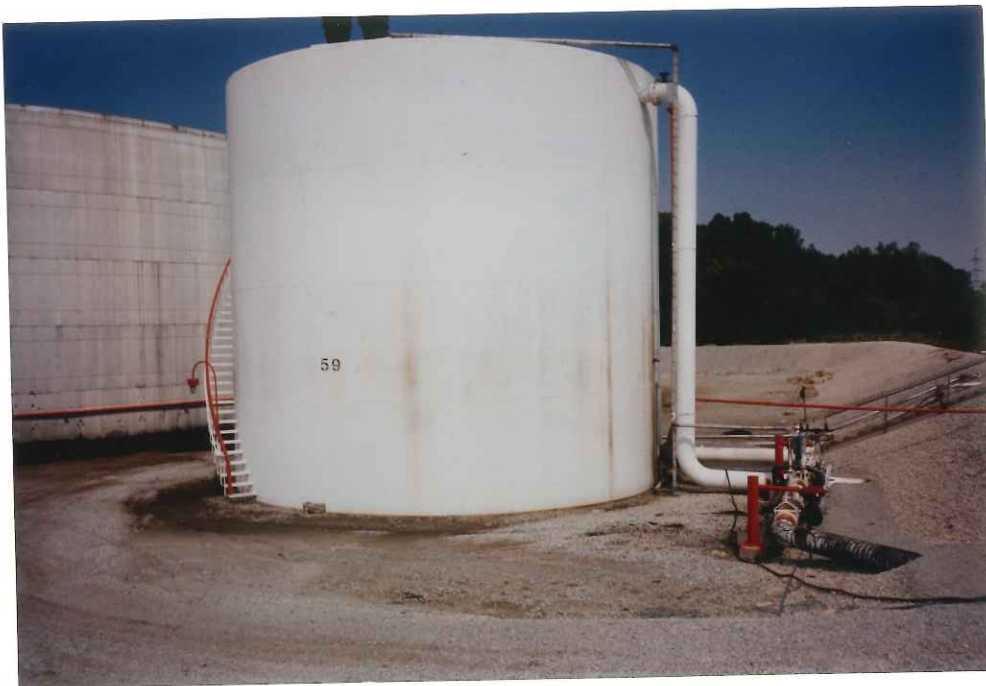
Photograph No. 19

Description: Treatment Tank #59 (center). This unit is an oil water separator. Note Tank #51 (left), an Asphalt Tank (AOC 1) leaking oil at base on left side of photo.

Location: SWMU 19

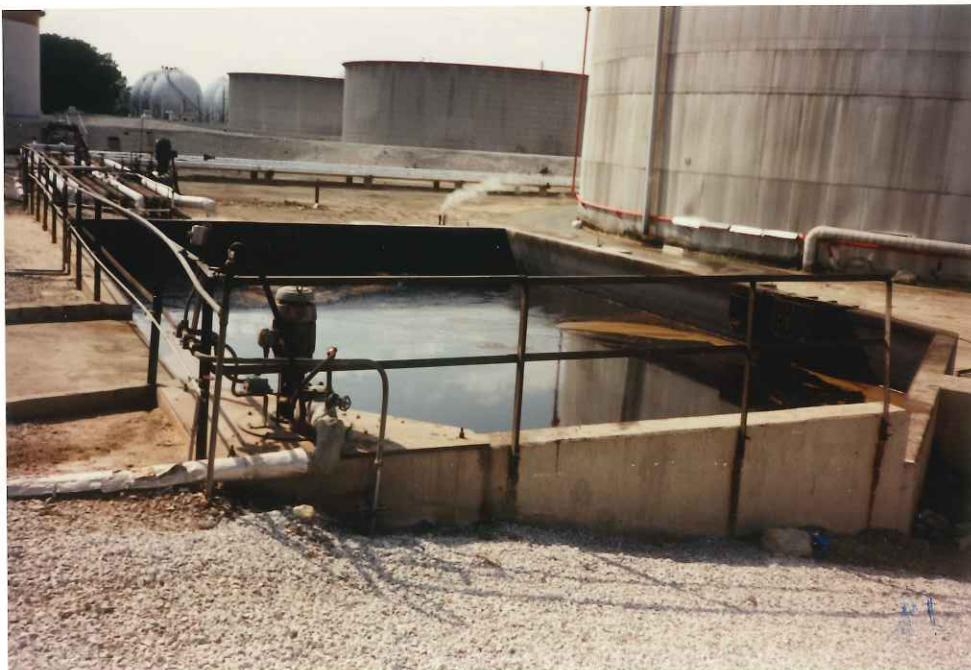
Photograph No. 20

Description: This 72,000-gallon overflow pit captures wastewater that Tank #59 cannot handle.

Location: SWMU 19

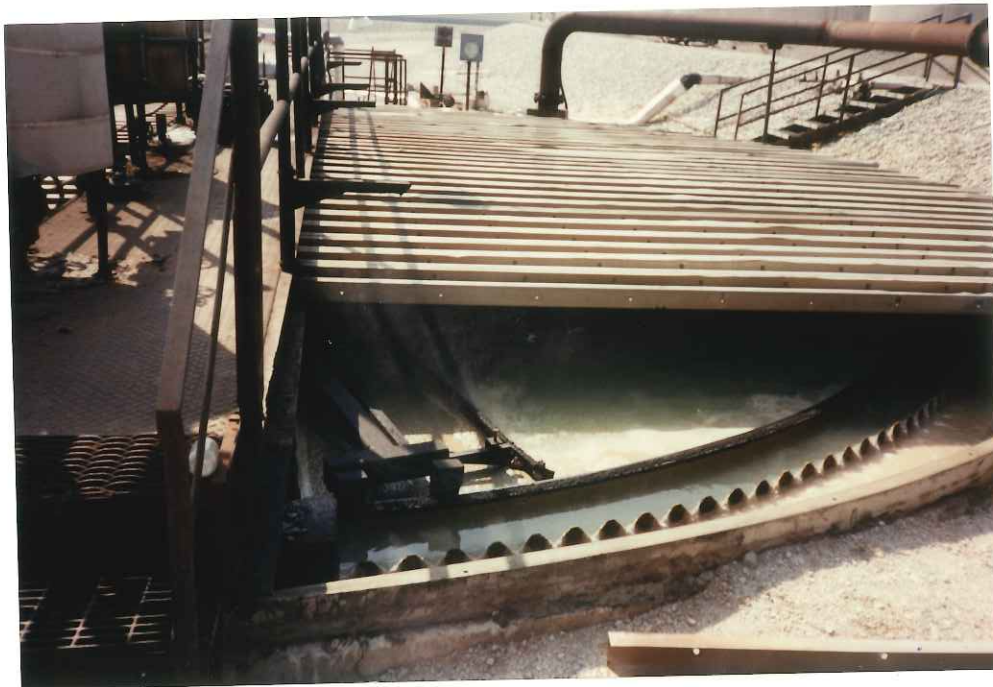
Photograph No. 21
 Orientation: South
 Description: An oil water skimmer, part of DAF oil water separator.

Location: SWMU 19
 Date: 08/21/91

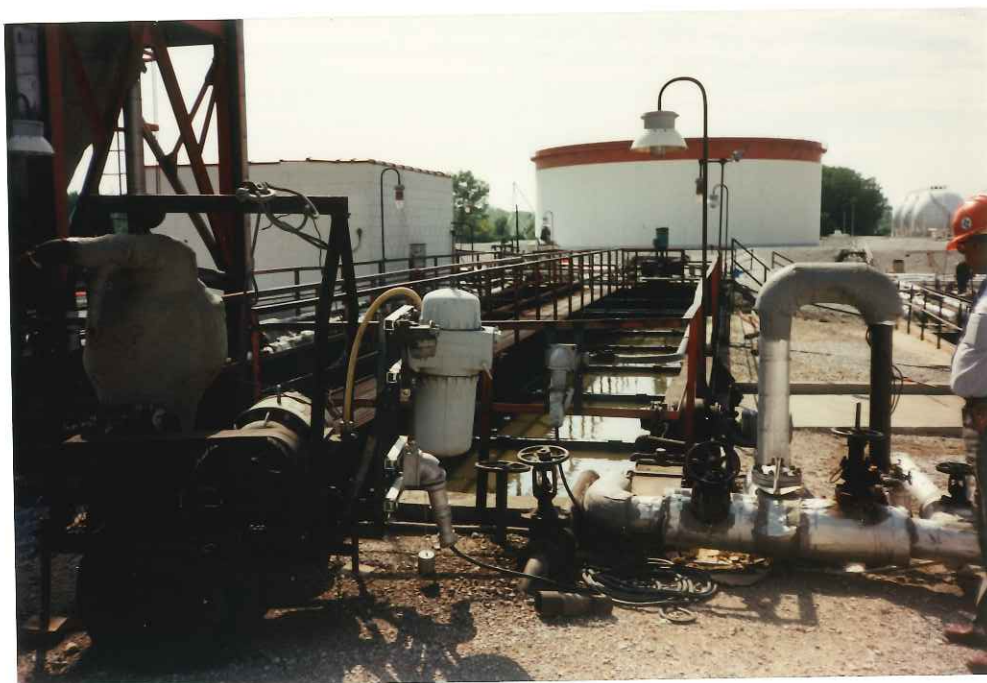
Photograph No. 22
 Orientation: West
 Description: Location of 2 API oil-water separators.

Location: SWMU 19
 Date: 08/21/91

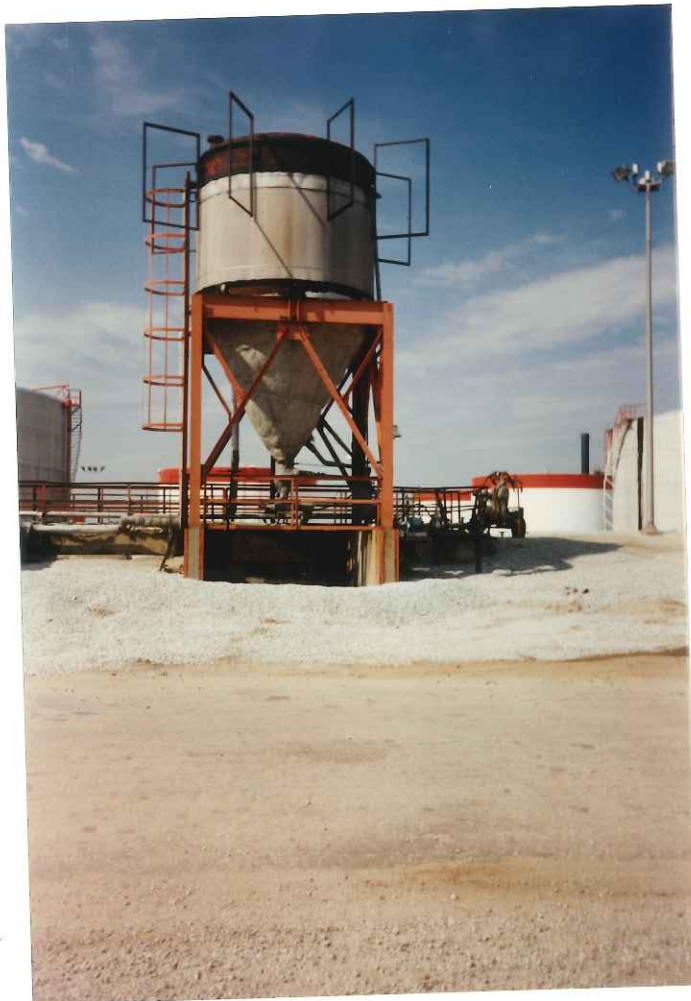
Photograph No. 23
Orientation: West
Description: The DAF oil water separator unit.

Location: SWMU 19
Date: 08/21/91

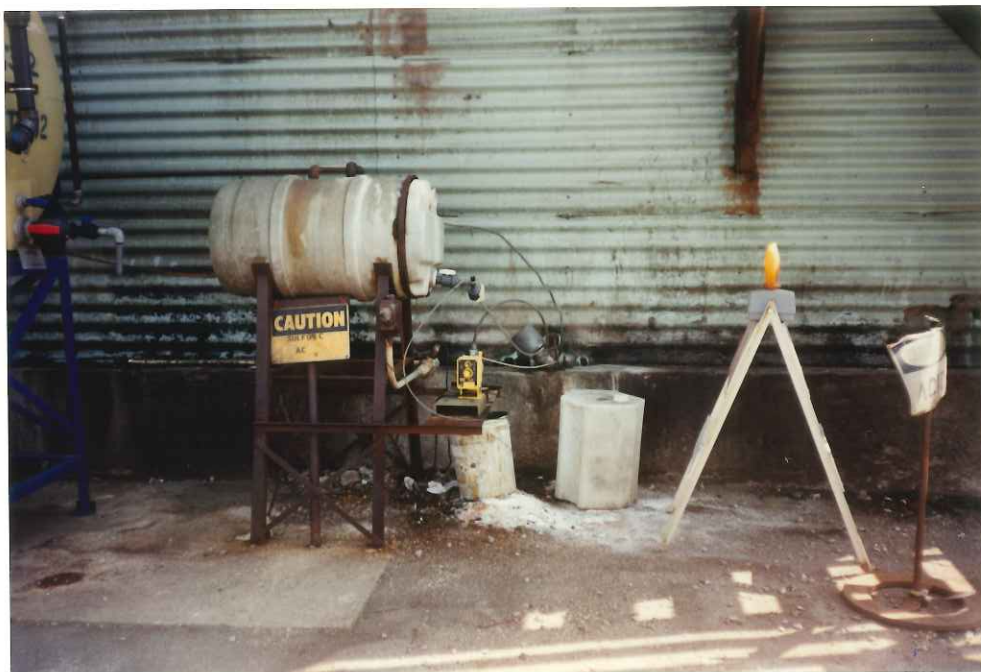
Photograph No. 25

Description: Cooling tower used by Water Treatment Plant for cooling boilers. Note sludge splattering on unit wall. Also note caustic on ground under sulfuric acid tank.

Location: SWMU 22

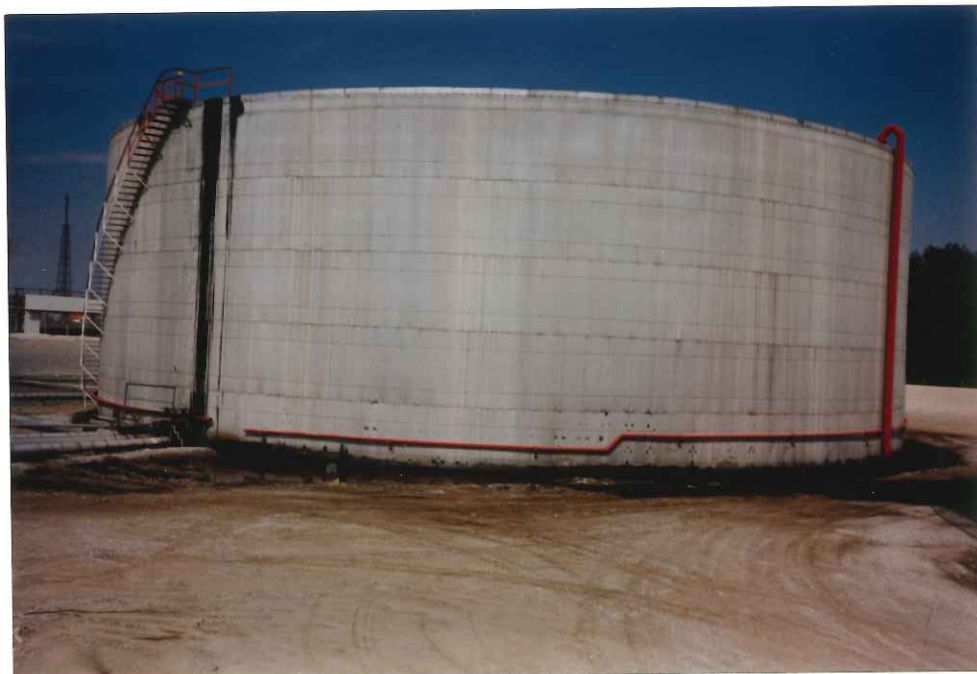
Photograph No. 26

Description: Asphalt Product Tank. Note oily liquid on soil at base of tank.

Location: AOC 1

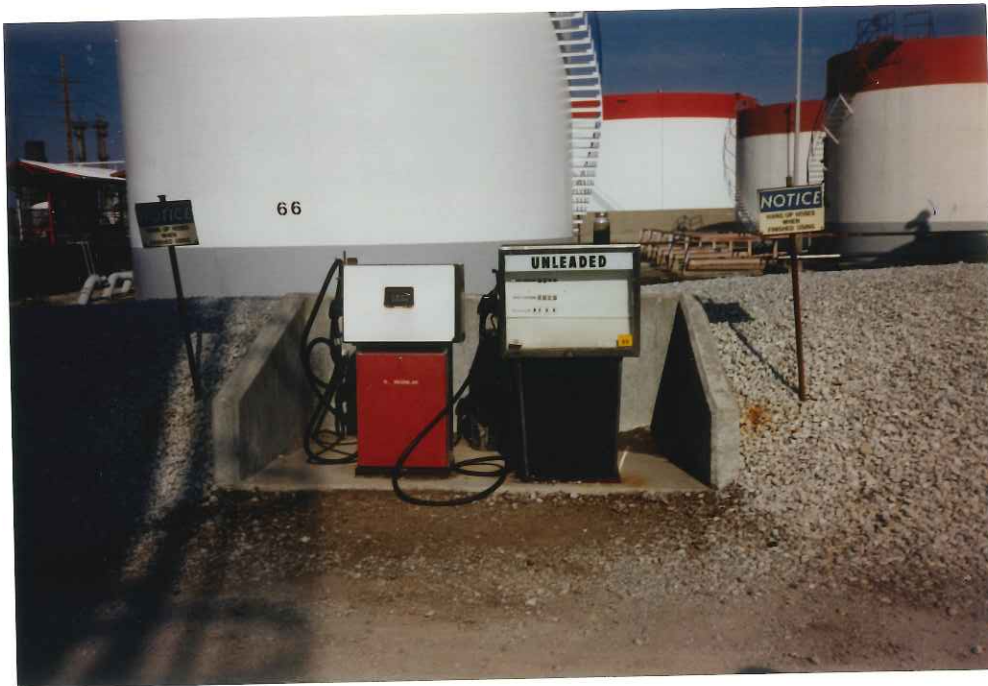
Photograph No. 27

Description: Location of two Underground Fuel Product Storage Tanks.

Location: AOC 2
